J. Słania\*, R. Krawczyk\*, D. Mastoń\*\*

# TECHNOLOGY OF WELDING JOINTS MIXED WITH DUPLEX STEEL

Results of the examinations of sample plates of mixed joints with the duplex steel were discussed. Examinations were taken on the sample plates of mixed joints of sheet plates type P355NL1 and X2CrNiMoN22-5-3 welded by the flux-cored wire DW-329A by the Kobelco company of the following category T 22 9 3 NL RC/M3 in the gas shroud M21 (Ar+18%CO<sub>2</sub>) (plate no.1), and nickel covered electrodes E Ni 6082 by the Böhler company (plate no. 2). Results of the side bend test of welded joint, transverse tensile test, stretching of the weld metal, impact strength, micro and macroscopic metallographic examinations, and measurements of the delta ferrite content were presented.

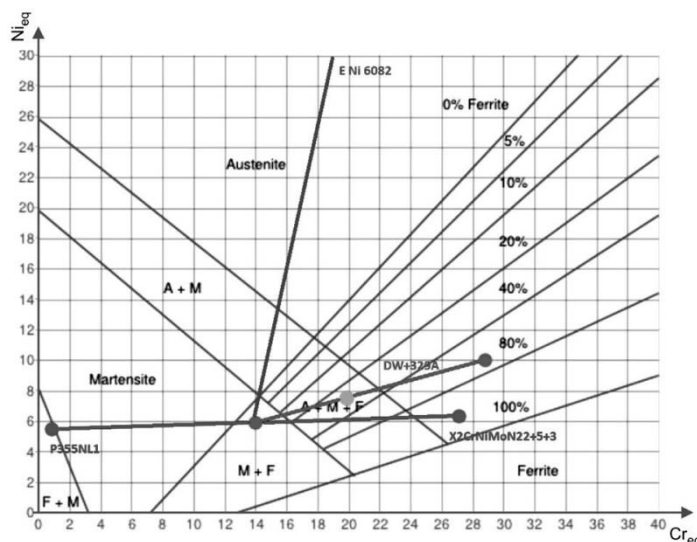
On the base of a chemical composition of both metal sheets and used filler materials, expected structures of the welds' materials made during processes were specified. The Schaeffler's diagram was used to illustrate it. (Fig. 1)

**Fig. 1** The Schaeffler's diagram [17]  
**Sl. 1** Dijagram Schaeffler-a [17]

After calculating an equivalent of chromium and nickel (formula 1, 2) and applying the results to the diagram, following data was obtained:

an austenite-ferrite-martensite mixed structure with an approximate value of ferrite 10% by using a flux-cored duplex wire.

a diagram does not cover in its range material of such high content of nickel (clearly shows a plain austenite structure) by using nickel covered electrodes

It is necessary to point that the Schaeffler's diagram relates to the constant cooling conditions of the weld, thus a real result may considerably differ. Above differences result from the dynamics of a welding process, and particularly an influence of heat which is difficult to predict, and the foremost conditions of cooling the weld [8-11].

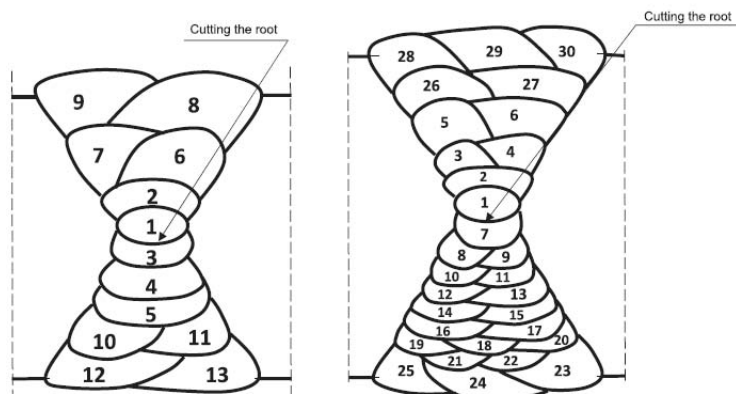
An order of applying beads is presented in the picture 2, while the real parameters obtained during the process of welding are included in the table 6.

**Fig. 2.** An order of applying beads

Used parameters allowed to obtain a proper amount of inserted heat (linear energy ranges from 0,3 to 1,7 kJ/mm), does not exceed recommended values (maximum value of a linear energy is 2,5 kJ/mm).

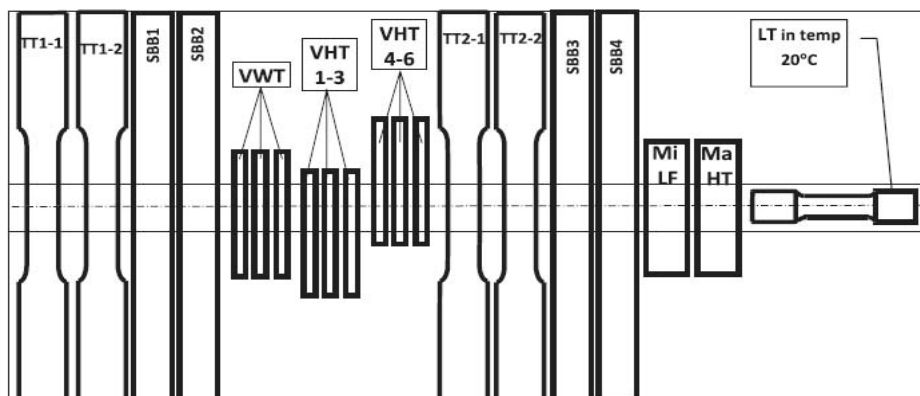
A way of collecting samples according to the PN-EN ISO 15614-1 is depicted in the picture 3.

**Fig. 3.** Places of collecting samples from the sample plates. TT– tension-torsion, SBB – surface band bending, Mi – micro, Ma – macro, VWT, VHT – notch impact value, HT – hardness testing, LF – ferrite number, LT – tension of weld metal [15,22]

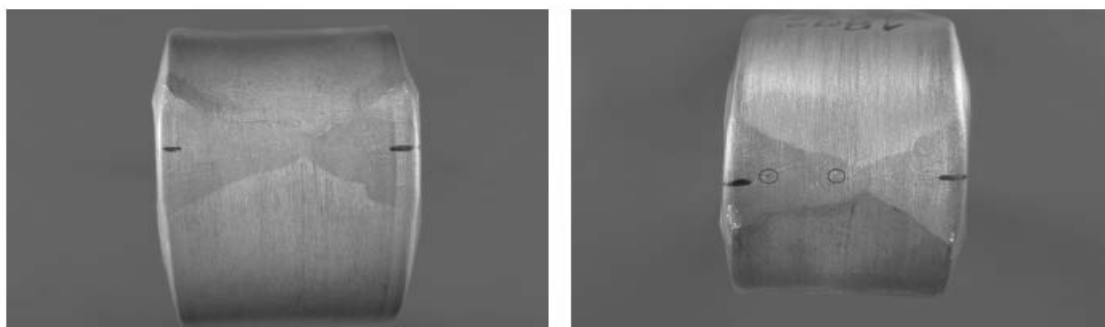
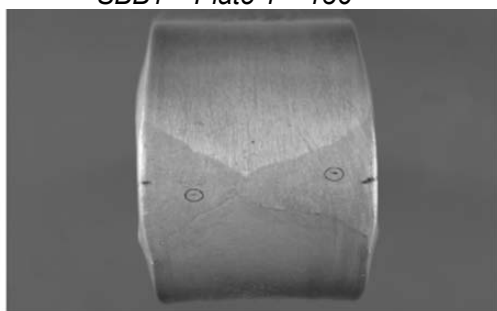
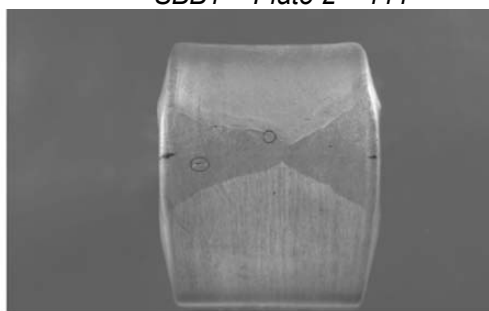
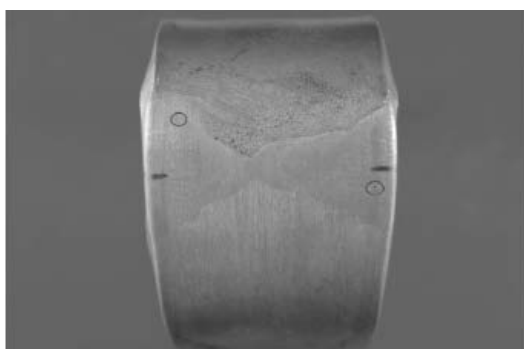
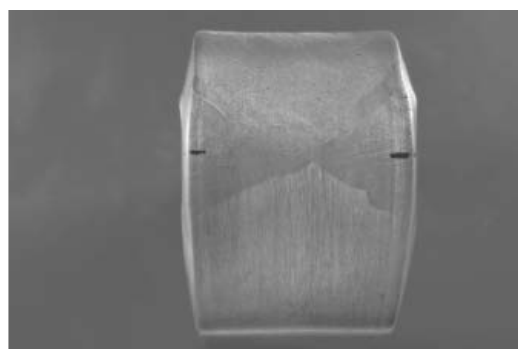
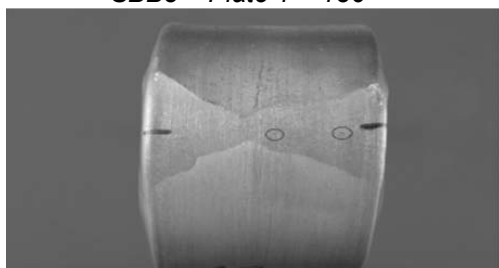
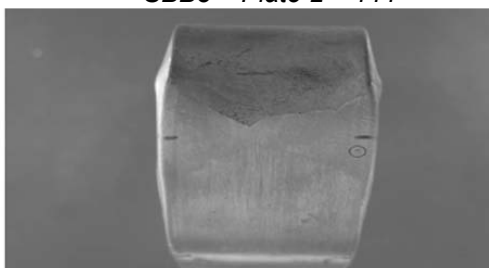
Pictures of the samples after side bend are presented in the picture 5.

Bending tests did not reveal any discrepancies in the base materials, welds and heat-affected zones. In case of both sample plates there appeared only slight cracks, which do not disqualify the joint. A result of an examination was positive (table 8, Fig. 5)

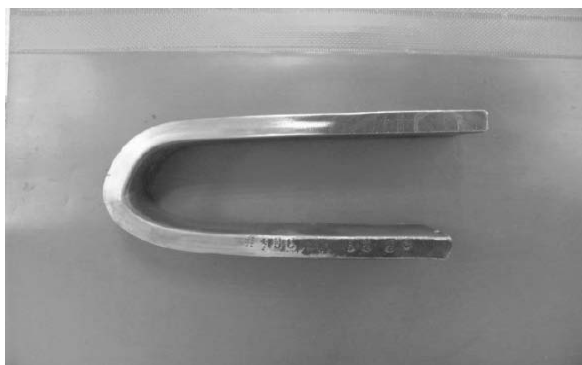
**Fig. 6.** A phenomena of non-axial deformation of bent samples  
**Sl. 6** Pojava neaaksijalne deformacije savijenih uzoraka

It is vital to point that PN-EN ISO 15614-1 standard allows to use 2 tests of bending longitudinal samples instead of 4 tests of side bend in case of mixed joints. It is done to avoid a problem of non-axial deformation of samples during examination, which is caused by too high difference of a resistance and plasticity of both materials. It was observed in the above experiment (Fig. 6). Above test was done in order to examine the joint in difficult technological conditions, therefore more risky 4 side bends were made [15, 18, 22].

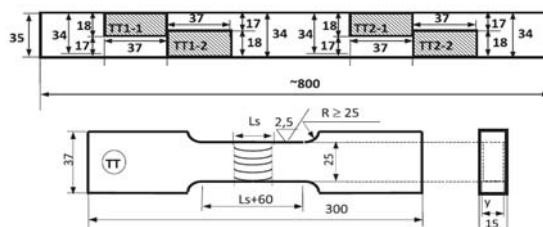
**Fig. 7. A way of taking and preparing samples for tension [23]**  
**Sl. 7. Način uzimanja i pripreme uzoraka za zatezanje [23]**

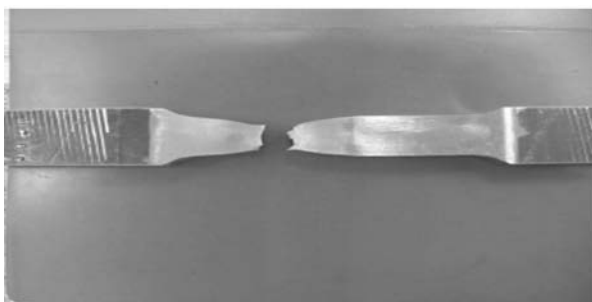
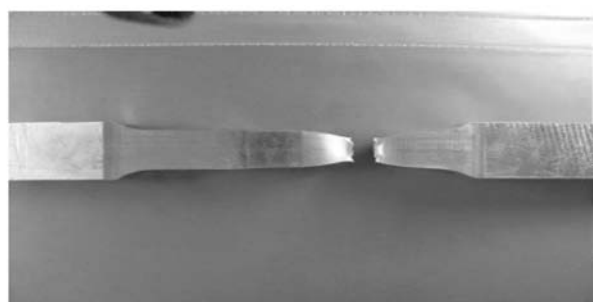
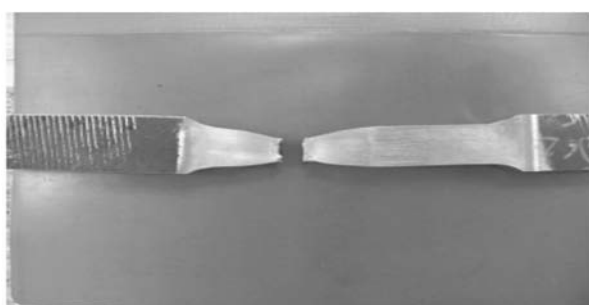
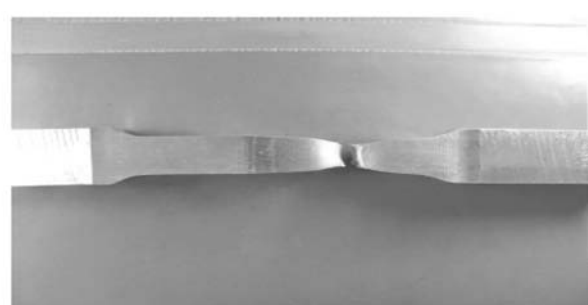
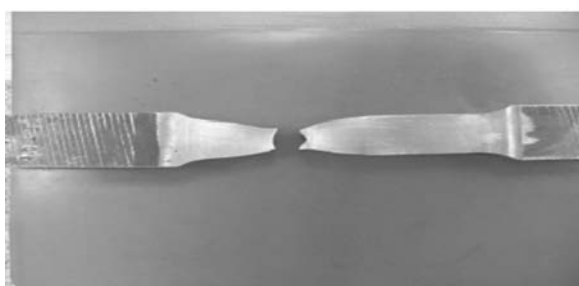
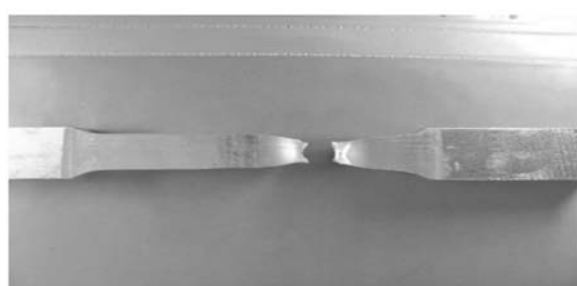
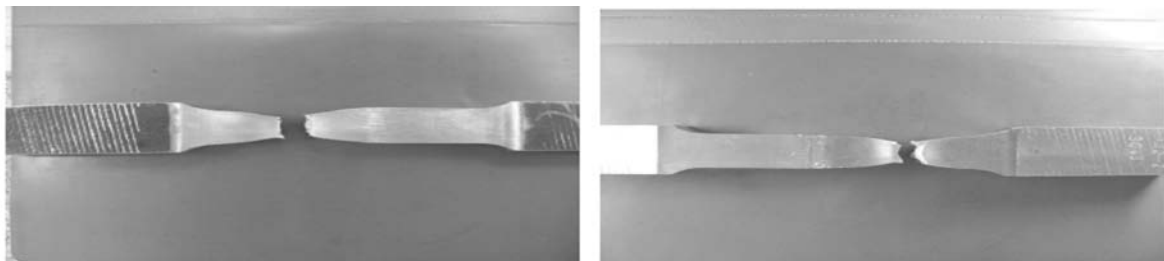
Pictures of the samples after transverse tensile are presented in the picture 8.

Tension tests proved that duplex steel is characterised by the greater tensile strength than the P355NL1 steel – samples were broken in the structural steel (fig. 8). An examination has finished positively, because a minimal resistance of the joint was obtained (table 9).

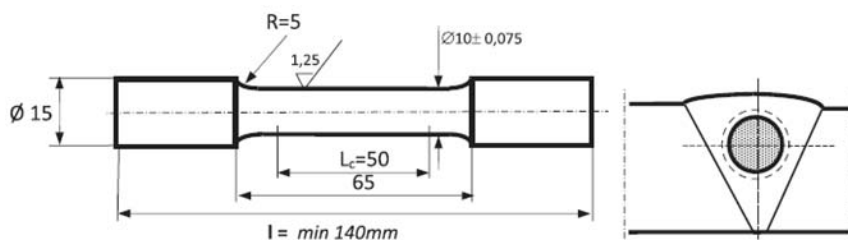
Ispitivanje zatezanjem metala šava je izvedeno u skladu sa standardom PN-EN ISO 876 kako bi se izmerila zatezna čvrstoća istog šava. Način pripreme uzorka predstavljen je na slici 9 [13].

**Fig. 9.** A way of taking and preparing a sample to stretch the weld metal. [26]**SI. 9.** Način uzimanja i pripreme uzorka za istezanje metala šava [26]

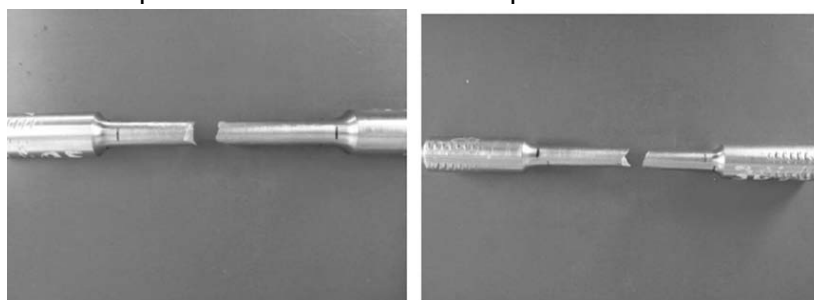
Pictures of the samples after tensile testing of the weld metal are presented in the picture 10.

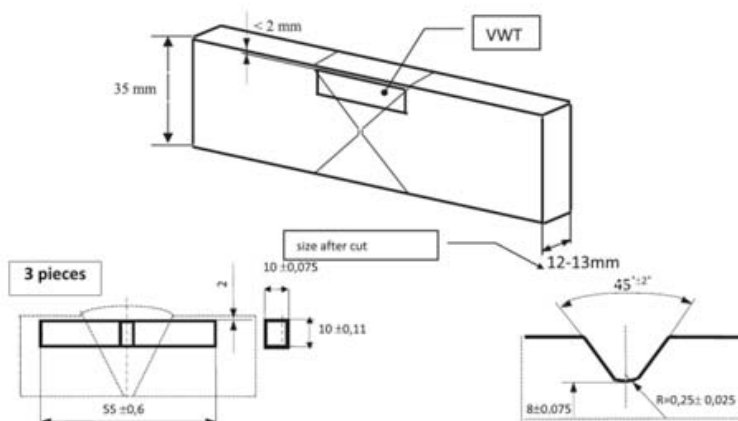
**Fig. 11.** A way of preparing samples taken from the weld to the impact strength tests [14]

Due to the mixed connection, except of a standard threeset samples taken from the weld and three from heat-affected zones, an additional set was used from the heat-affected zone of the second material. Recommendations from PN-EN ISO 9016 and PN-EN ISO 148-1 standards were used. Pictures 11 and 12 depict a way of taking each set. An examination was = 300 J weight [24, 25]

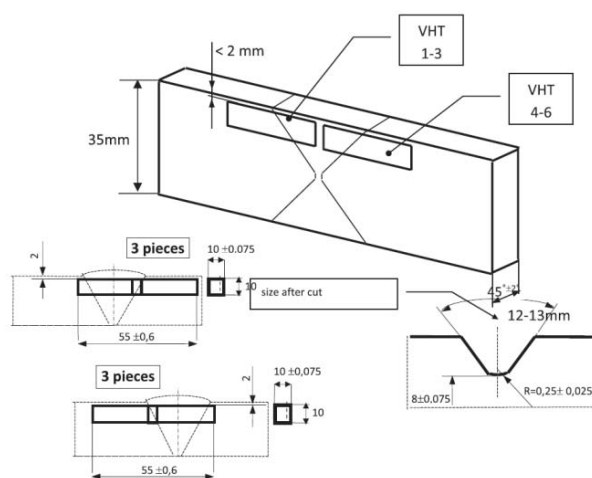
**Fig. 12.** A way of preparing samples taken from the heat-affected zones to the impact strength tests [14]

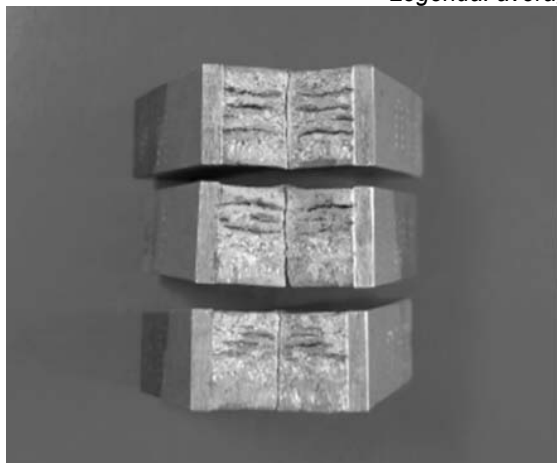
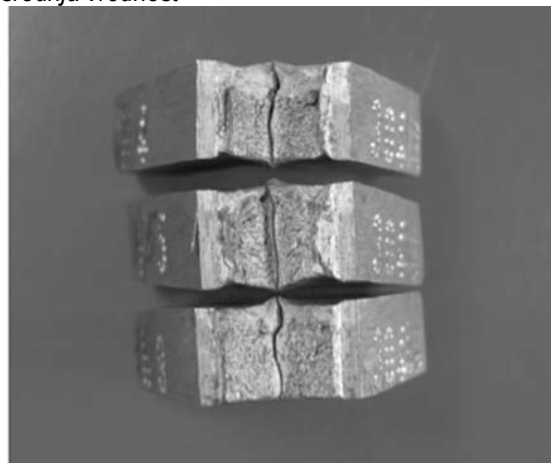
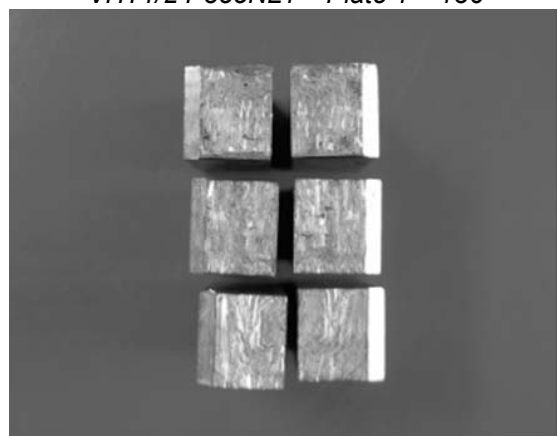
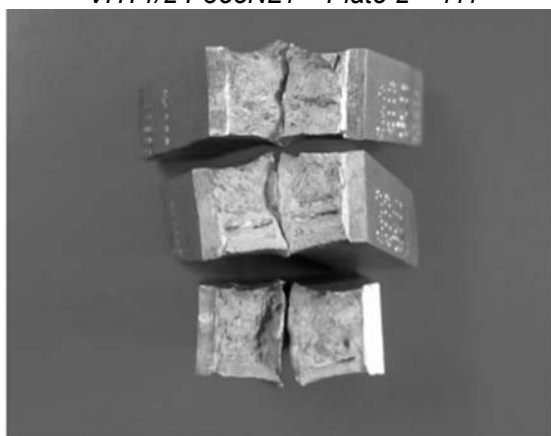
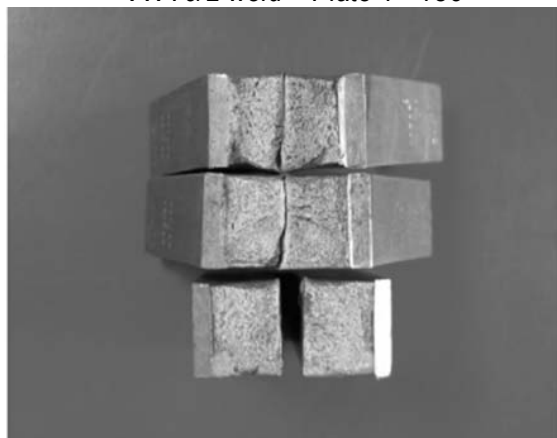
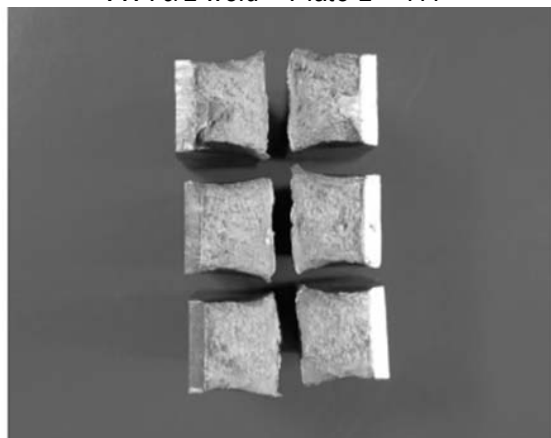
**Fig. 13.** Pictures of samples after an impact strength test  
**SI. 13.** Slike uzoraka posle ispitivanja udarom

Impact strength tests have finished negatively in case of the plate no. 1. A required value of breaking operation equals to 27 J was not obtained both for P355Ni1 material, and also 40 J for the duplex steel (table 11). It is caused by an increase of embrittlement activated by the carbon diffusion from the carbon steel into the weld during a thermal treatment, and an occurrence of the brittle sigma phase.

Elements included in the chemical composition of used electrodes mostly nickel, niobium and titanium, which are stabilizers, stopped carbon diffusion. Moreover, they caused appearance of carbides, which increase embrittlement and decrease resistance of the material to corrosion. Pictures prove that samples taken from the nickel welded joint (plate no. 2) broke in a plastic way, while the fracture of samples from the plate no. 1 is evidently brittle.

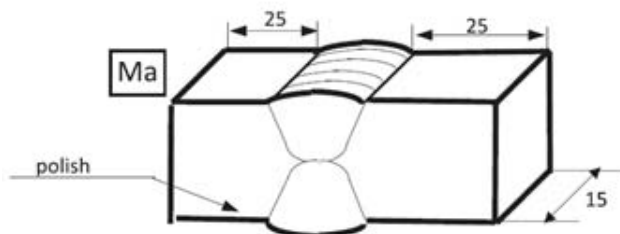
Makroskopsko ispitivanje je izvedeno u skladu sa standardom PN-EN 1321 na prethodno uzetom i obrađenom metalografskom uzorku (slika 14). Za nagrizanje je korišćen Adlerov rastvor [20]

Fig. 14. A way of preparing a metallographic specimen [10]

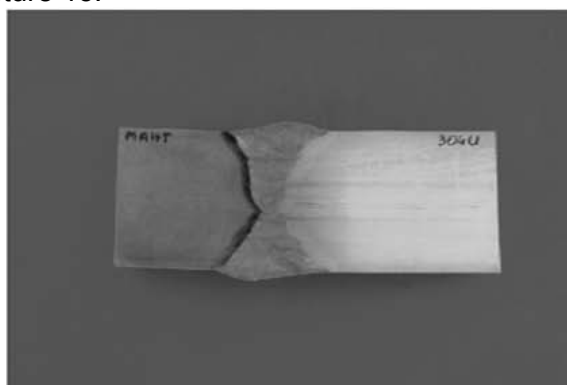
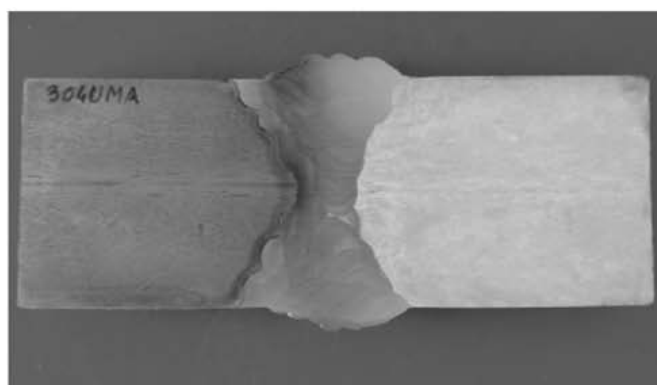
Macroscopic pictures of plates are presented in the picture 15.

Fig. 15. Macroscopic pictures of plates

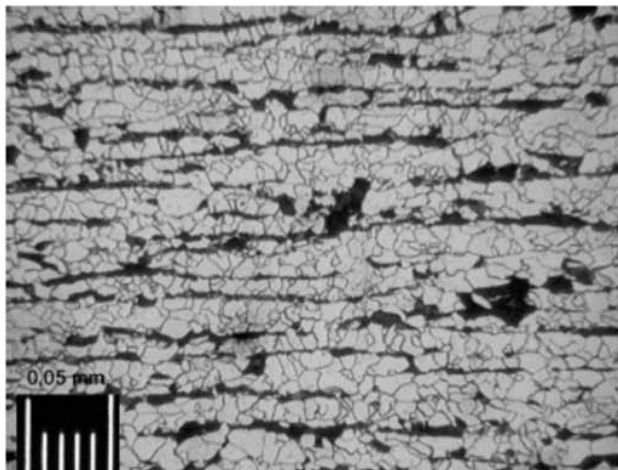
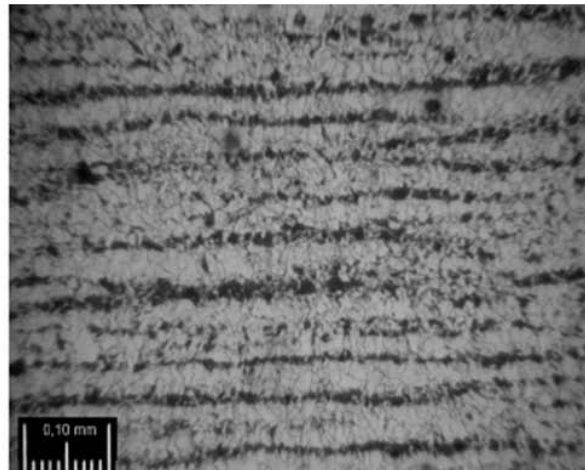
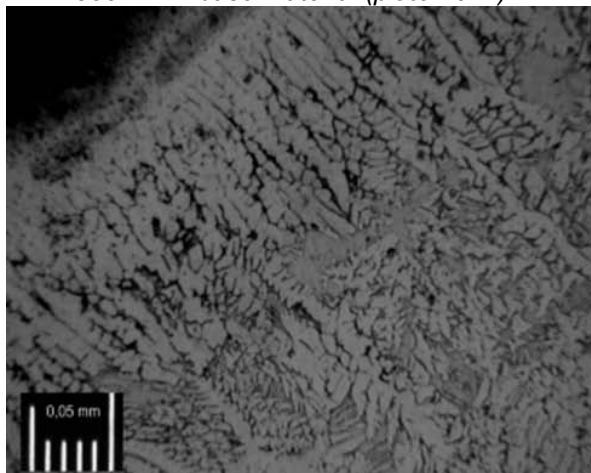
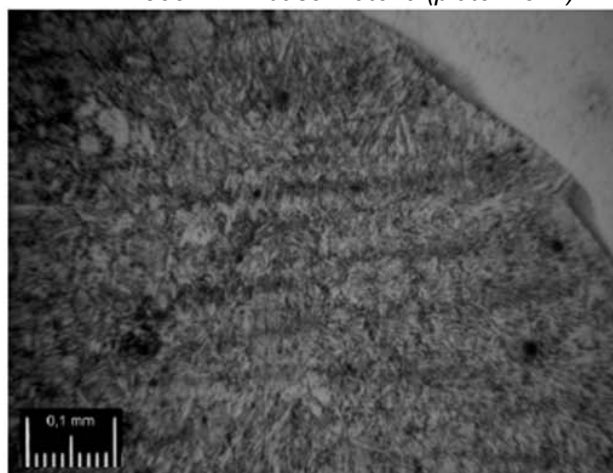
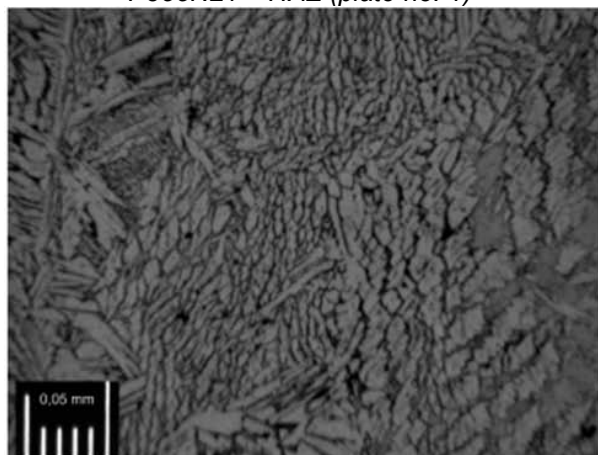
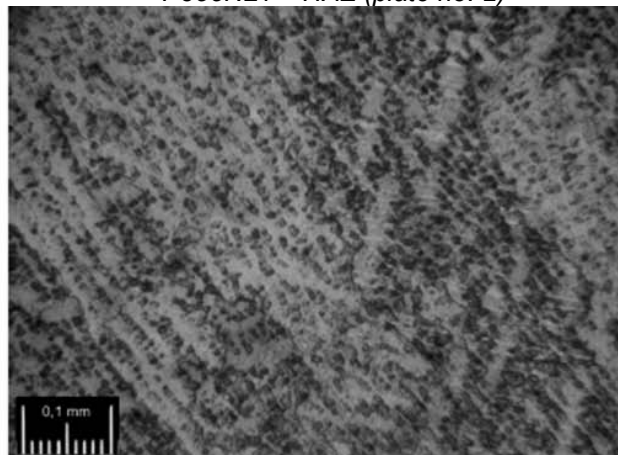
Mikroskopske slike su uzete na metalografskom uzorku koji je nagrižen agensom koji se sastoji od nitala i Mi20Fe (slika 16). Uvećanje je 200: 1. Ispitivanje je izvedeno prema standardu PN-EN 1321 [20]

**Sl. 16.** Mikrostrukture limova

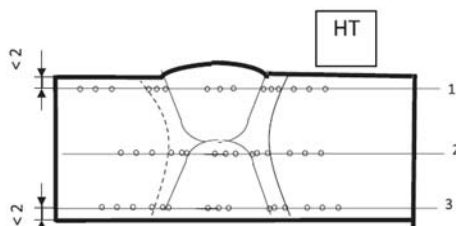
Ispitivanje tvrdoće po Vickersovoj metodi obavljeno je na metalografskom uzorku, ranije korišćenom za makroskopski pregled. Ispitivanje tvrdoće je obavljeno prema standardu PN-EN ISO 9015-1 duž određenih mernih linija (slika 17). Korišćeni uređaj je Vickers 430 SVD sa opterećenjem HV10 [19].

**Fig. 17. A way of doing a hardness test [19]**  
**SI. 17. Način merenja tvrdoće**

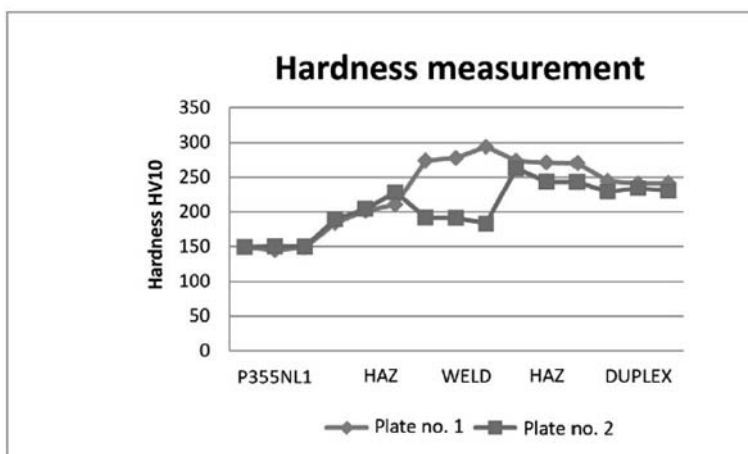
Results of the hardness tests are depicted in the picture 18      Rezultati ispitivanja tvrdoće prikazani su na slici 18

**Fig. 18. Results of the hardness measurement**  
**SI. 18. Rezultati merenja tvrdoće**

In case of the plate no. 1, the lowest hardness was stated inside the P355NL1 metal sheet, its value is much higher in the duplex steel, and definitely the highest in the weld (table 12, 13). Hardness of both base materials plate no. 2 is very close to the measurement of the plate no. 1, whereas in case of the weld much lower hardness was observed in the joint made by the nickel based electrodes. It is caused by the high plastic properties of mentioned electrodes.

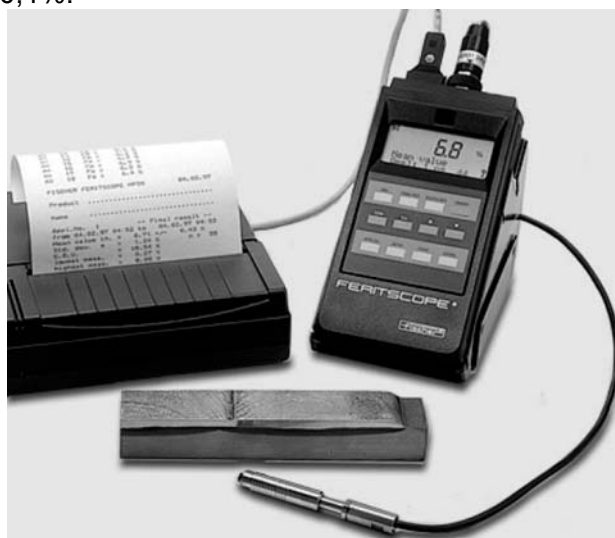
Ispitivanje sadržaja delta ferita obavljeno je u skladu sa standardom PN-EN ISO 8249 uređajem Fischer MP 30E-S Feritscope (slika 19) na prethodno korišćenom metalografskom uzorku. Merenja obuhvataju površinu metsala šava, dupleks čelik i crni čelik [21].

**Fig. 19. The Fisher MP 30E-S Feritscope**  
**Sl. 19. Fisher MP 30E-S Feritscope**

In case of both sample plates a content of delta ferrite in the structural steel ranges from 96 to 100%. There was a considerable decrease of ferrite share (plate no. 1) in the duplex steel from the joint welded by the flux-cored wire in comparison to plate no. 2. The weld made by the duplex wire is characterized by the dual microstructure. A device cannot measure a content of delta ferrite in the nickel weld due to insufficient sensitivity of the feritscope. Thus, it can be stated that a share of delta ferrite does not exceed 0,1%.
