Maja B. Poser¹, Filip Zdraveski^{1,a}, Martin Petrevski^{1,b}, Miloš Pavlović², Vladan Jeremić²

HARDFACING ALLOYS FOR EXCAVATOR TEETH COATING

Original scientific paper / Originalni naučni rad

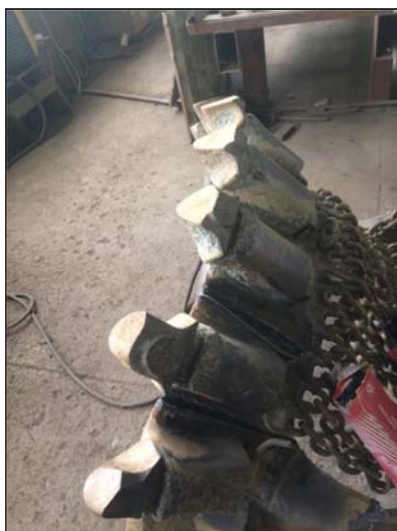
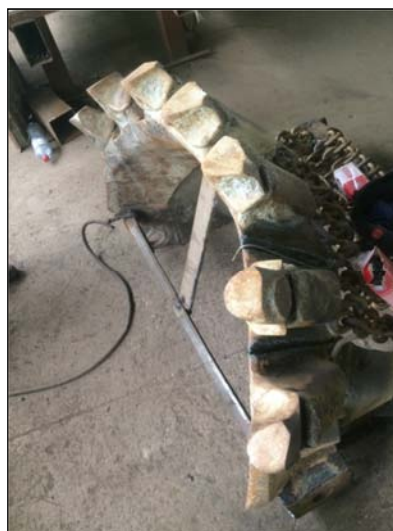
Figure 1. Blunt bucket teeth

In the mining industry, the abrasion of the components is a common occurrence in machines that perform excavation, transport and processing of ores and minerals. Abrasion is often significant, leading to component failure (Figure 1) that has a significant economic effect on the process [1].

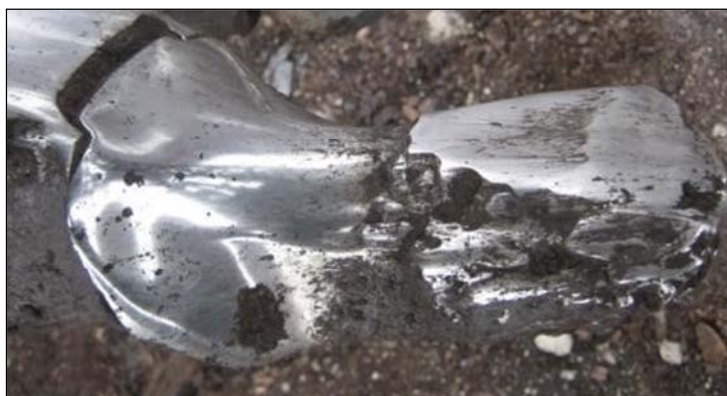
Figure 2. Delamination of hardfaced layers

balanced criterion between a relatively good toughness and enough hardness to withstand abrasive factors. Nevertheless, under load, the teeth coated with hardened materials may be subjected to cracks propagating through the thickness of the coating or interfacial decohesion (Figure 2) which leads to failures.

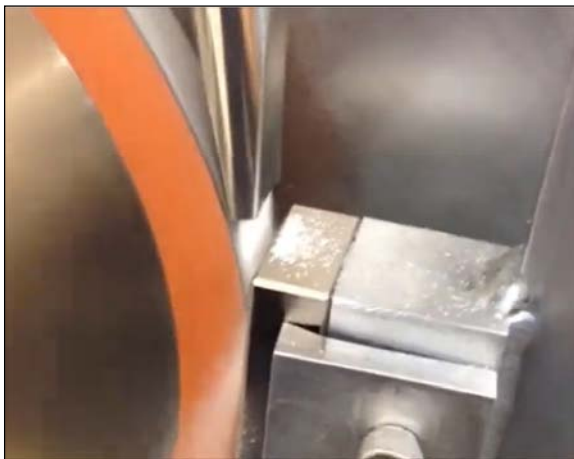
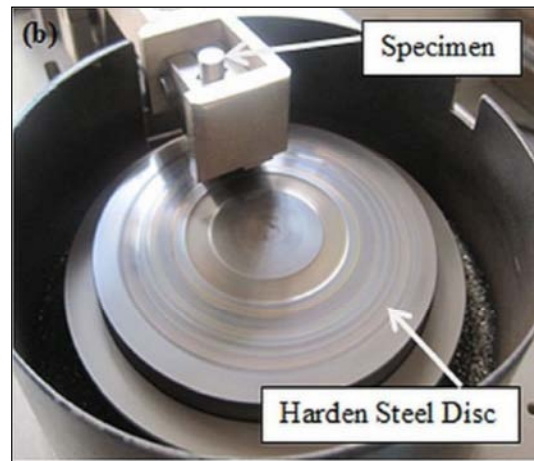
Figure 5. Test methods: (a) specimen against rubber disk with abrasive material and (b) pin on dry disk

Laboratory tests used to evaluate the degree of abrasion are the methods: pin on dry disc with 62-65 HRC, dry test of rotating vulcanized rubber disc with abrasive granule against the sample, and test of rotating vulcanized rubber disc with abrasive granule submerged in water against the sample (Figure 5).

A testing force is applied to the sample which, depending on the standard, can be from 30 to 200N. The linear testing velocity of the specimen is approximately around 1 m/s.

Test specimen for the pin on disk method is cylindrical pin of diameter 8mm and length 30mm, hardfaced at their cross-section on one side and subsequently machined to specified sized.

Test samples for test method against vulcanized rubber and abrasive sand are prismatic blocks with dimensions 54x20mm, and 20-24mm thick. They

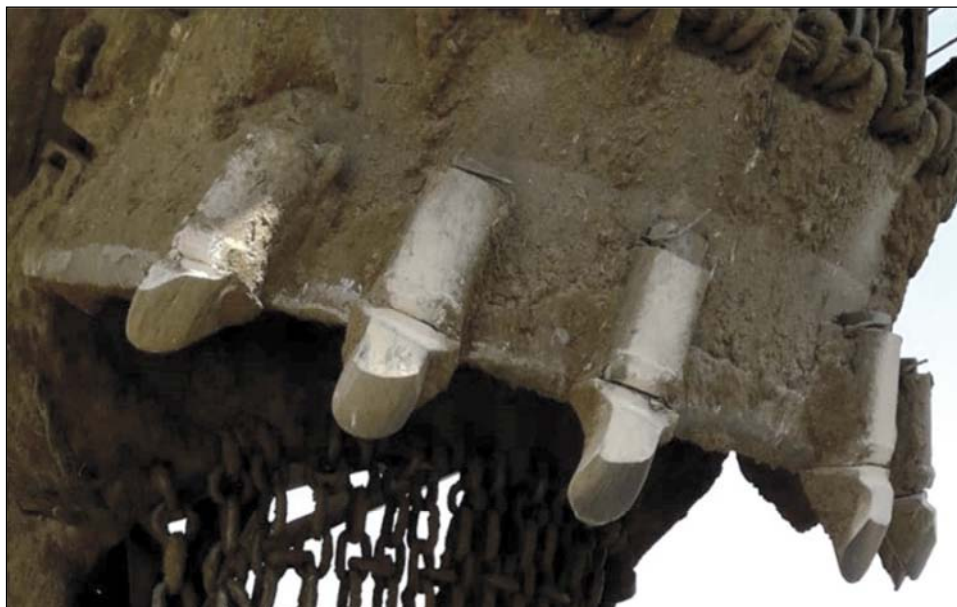
Figure 6. Influence of tooth position on degree of abrasion in SRS 2000 rotor excavator

Unfortunately, the only method that ensures a right evaluation of the component performance is to carry out real field test, which is very tedious and expensive procedure. Field testing of the bucket teeth is complicated because the position of the teeth on the bucket has an important influence on wear (Figure 6). More testing should be carried out, where the teeth will be changed to different positions and on different baskets to minimize the influence of their position [15].
